## Objectives

In May of 2018, to independently validate the new 2-7/8 AMP, InFocus conducted 3rd party dyno testing of the power sections at a third party provider in Red Deer, AB. The objective was to demonstrate repeatable high torque and extended run time performance of InFocus' 2-7/8" AMP (ALL METAL POWER) sections.

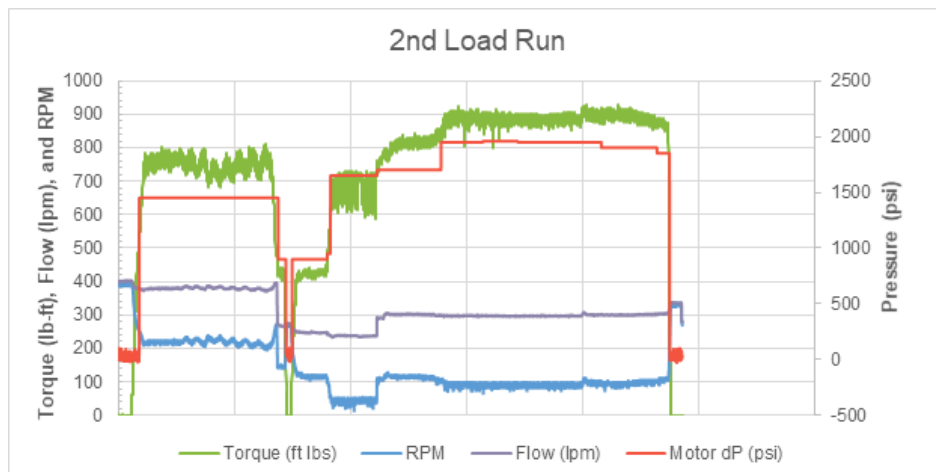
**Figure 1 - Graphical results of 2nd Load Run**

Tests were very successful and proved the AMP power section can operate at a variety of load conditions, and can transition easily between loading conditions, all while putting out very high torque for it's size in a sustained (>30min) high load test. Data from the 2nd load run, where maximum torque of 890 lb-ft was achieved and sustained, is plotted in Figure 1.

- (b) The stable load was 410 lb-ft at a diff pressure of 900 psi. This was steadily increased over 25 minutes until a torque of 890 lb-ft was reached at a diff pressure of 1,950 psi.

- (c) This 890 lb-ft load was held for over 30 minutes at a speed of just under 100 RPM with no drop in performance or change in diff pressure.

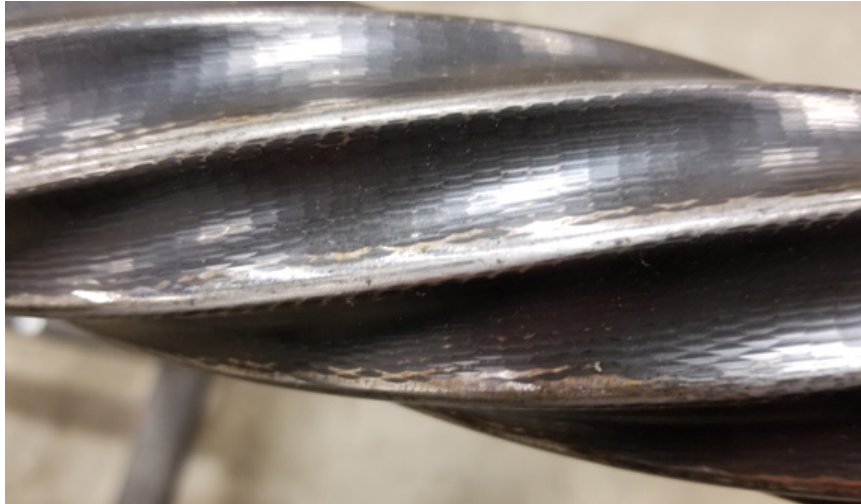
**Figure 2 - Closeup of rotor contact patch**

Contact appears to have occurred along one side of the profile of the rotor lobe, and in some locations extended to the rotor lobe tip. This is the side where the rotor rolls into the stator. This contact patch does not appear to have any divots or dents or even a step change in lobe thickness. The rotor profile still feels smooth and looks like the contact is more of a polish than any appreciable wear.

**NOTE:** The rotor was manufactured to a milled finish, resembling "snake skin". The scaling seen is from the manufacturing process and not from dyno testing.

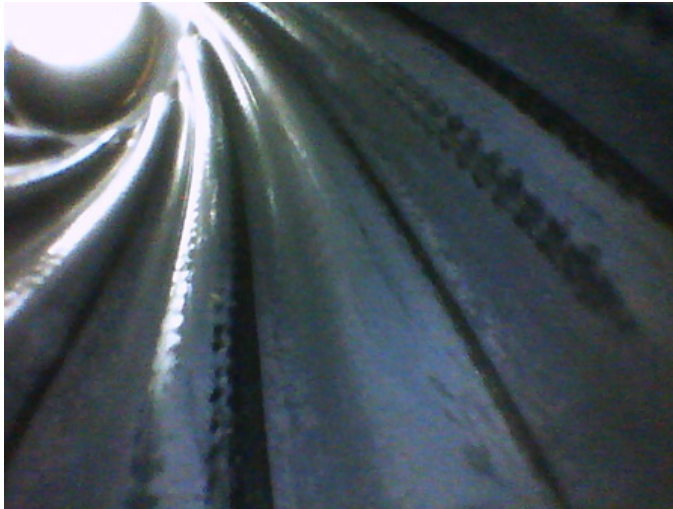
Figure 4 - Post-run borescope of stator

The stator was evaluated via visual inspection with a borescope, as well as tactile evaluation.

Contact appears to be on the flanks on either side of the stator minors, where the rotor makes rolling contact with the stator. The contact patches are smooth, and free of divots and dents. The edges of the contact patches are gradual and no step changes or indents are visible. This wear pattern is consistent through most of the stator. As seen on the rotor, this contact appears to be mostly polish rather than any appreciable wear.
