Overview

Date: 21 Oct 2019
Location: Kuwait
On/Offshore: Onshore
Open Hole: 12.25"
Section Length: 9,733 meters
Casing Spec: 9.625", 43.5 & 47 ppf, L80 BTC, L80
Location: Lower Burgan Shale
Hole Issues: Wellbore Instability, Shale caving

Objectives

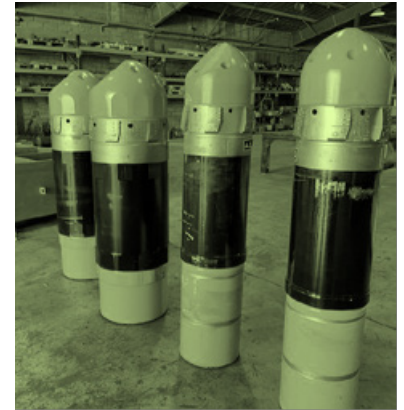
Run 9 5/8" casing with the 9 5/8" HSRT reamer shoe to target TD in the Lower Burgan shale at 9,733 feet. Overcome any wellbore instabilities, cavings, shales and fill by utilizing the unique hydraulic rotating feature of the HSRT reamer shoe.

Engineer made up the 9 5/8" HSRT tool to the first 9 5/8" casing. The tool was picked up, run below rotary table and tested with a flow rate of 100 GPM (producing approx. 150 RPM). RIH operation commenced and bottoms up was circulated at the 13-3/8" shoe @150GPM's. Casing RIH to 7,390 ft. and HSRT tool was activated due to several tight spots while POOH with DP. String was worked down to 7,900 ft where no obstructions were observed. Obstruction was observed @9,700 ft, picked up string to 9,680 ft, engaged pumps and reamed from 9,680 ft to 9,733 ft with flow rate starting from 150gpm and increased to 200gpm then to 500gpm. TD was reached, circulated bottoms up and prepared for cement job.

The HSRT reamer was utilized throughout the open hole section and performed as expected. In some previous offset wells, the 9 5/8" casing string did not reach TD with conventional reamer shoes, resulting in an additional liner section to be added to the wellbore construction.

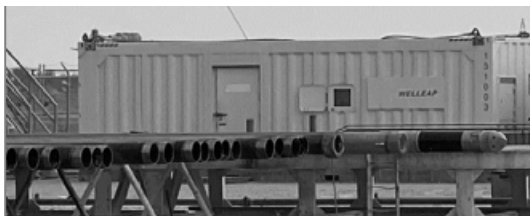
Bit: 8-1/2" PDC
Duration: 1 hrs
Parameters: 300 gpm, 600 rpm, 15 kips
